Engineer Killed in Train Wreck

Inyo Register November 1926

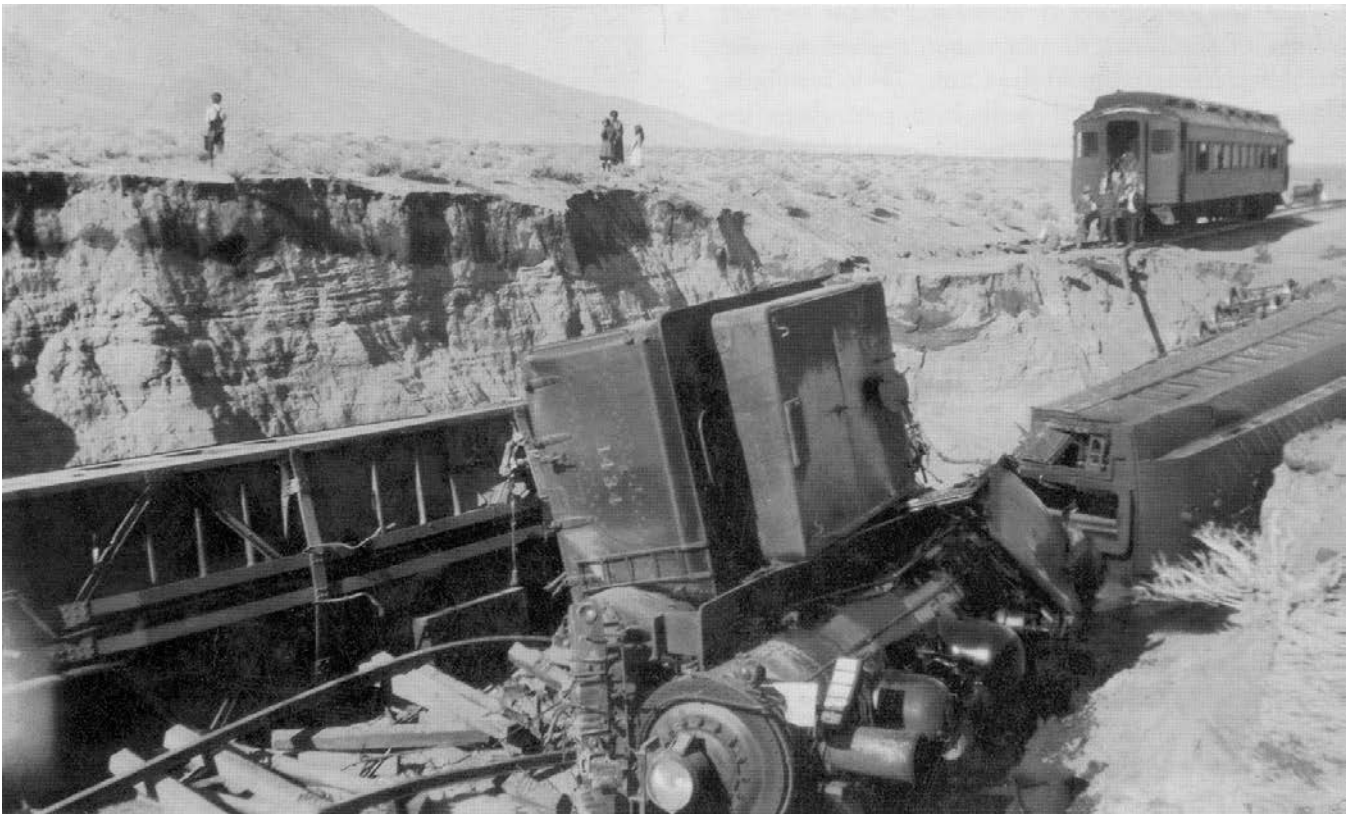
It is reported from Los Angeles that the cause of the washout was the bombardment of the aqueduct by tons of boulders from the hillside above, during the torrential rains of the closing days of last week. While the aqueduct there is concrete lined, its walls gave way when its already full channel was blocked by debris. Two sections of the ditch were cut through and breaks estimated at 200 and 500 feet in width opened. The flood of water, augmented by drainage from the higher country to the west, poured toward the lake bed, and undermined the tracks. This is said to have occurred about 5 o'clock in the morning. Whether no one was aware of the condition, or through reprehensible failure, no warning was given for the benefit of the trainmen who were to come along a few hours later. Fuller, driving his engine, ran into the break, and to his death. The locomotive, tender, baggage car and one coach were wrecked. The hole across the roadbed was 14 feet deep and 300 feet across.

Reports reaching Los Angeles from the aqueduct break said that the breaks in the canal were from four to twelve feet deep, that one gap was 206 feet wide and another 560 feet. A camp was promptly established on the scene, and all available men were rushed there to repair the breaks, a work which will take several days at the best.

A report in Tuesday's *Examiner* stated that the gulch washed was 50 feet deep, and that 25,000 yards of earth would be put in before relining the aqueduct would begin, Mulholland explains that debris filled the channel and overflowing water then undermined the concrete.

Allegations made by those familiar with the wash-out section of the aqueduct are that the cement wall along there is but four inches thick, and its weakness is given as the cause of the damage. Inspection of the canal at the spillway and other points southerly shows a great deal of disintegration and unquestionable weakness.
